Manhole Inspection Summary

Manhole # S53U1_002MH

Insp Date: **6/2/08 11:46 AM**

Location Address: **2000 Frankfurst Ave.**

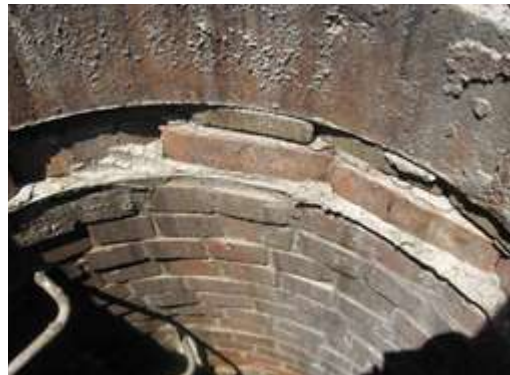
Defect 1

Condition: ☐ Sound ☒ **Cracked** ☐ Root Intrusion ☐ Loose Brick ☐ Deteriorated

Cracked Frame-Chimney joint.

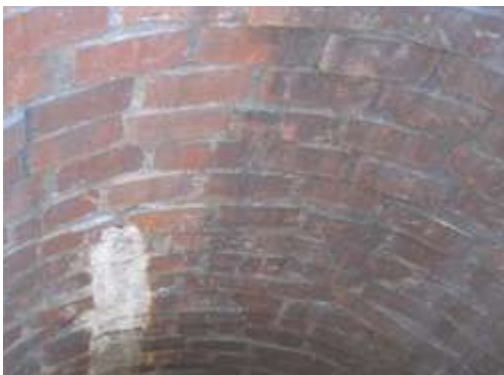
Defect 2

Infiltration: ☐ None ☐ Joint ☐ Cracks ☐ Mortar ☐ Roots ☒ **Wall**

Infiltration through the wall.

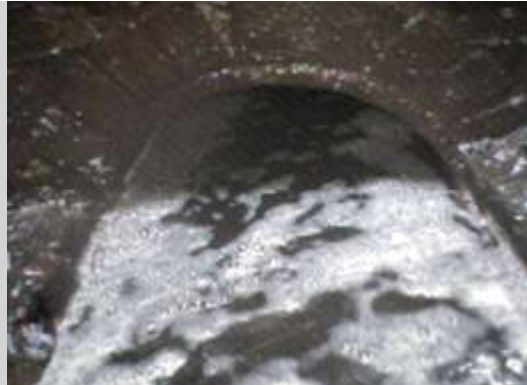
12 O'Clock Outflow

Pipe Height: **16.8** (in.) Rod and Bar (Angled)
Pipe Material: **Clay** ☐ Pipe Lined
Invert Depth: **12.48** (ft.) Flow Characteristics: **Fast**
Deposits: ☒ None ☐ Mud ☐ Sludge ☐ Debris ☐ Grease
Silt Depth: (in.) Deposits Extent:
Infiltration: **None** Pipe Seal Cond: **Sound**

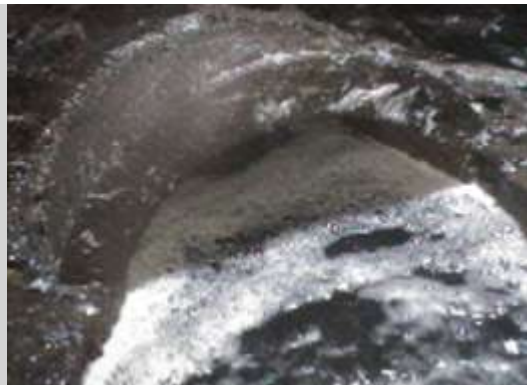
5 O'Clock Inflow

Pipe Height: **16.8** (in.) Rod and Bar (Angled)
Pipe Material: **Clay** ☐ Pipe Lined
Invert Depth: **12.56** (ft.) Flow Characteristics: **Turbulent**
Deposits: ☒ None ☐ Mud ☐ Sludge ☐ Debris ☐ Grease
Silt Depth: (in.) Deposits Extent:
Infiltration: **None** Pipe Seal Cond: **Sound**

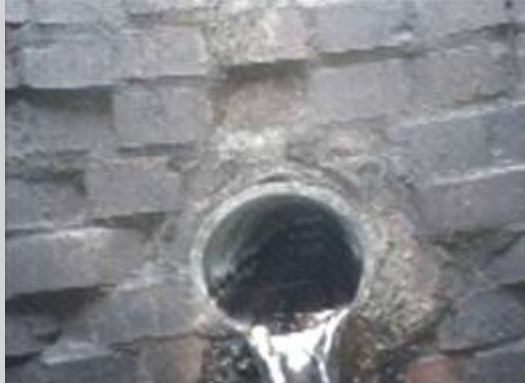
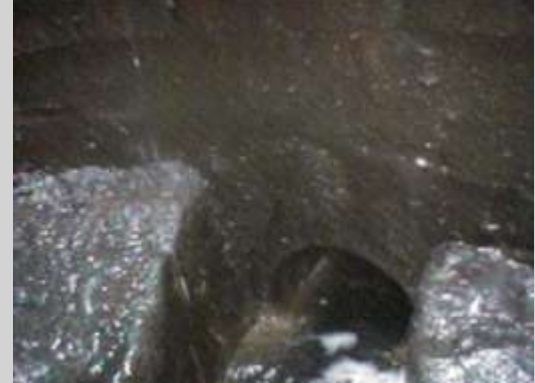
9 O'Clock Inflow

Drop: Outside	Rod and Bar
Angled: Yes	Reading: 10.90 (ft.)
	Inv Depth: (ft.)
Drop Condition: Open
